# Monitoring the changes in the dynamic properties of an RC building experiencing column loss

Fuat Aras<sup>1</sup> · F. Necati Çatbaş<sup>2</sup>

Received: 3 April 2023 / Accepted: 20 February 2024 / Published online: 26 March 2024  
© The Author(s) 2024

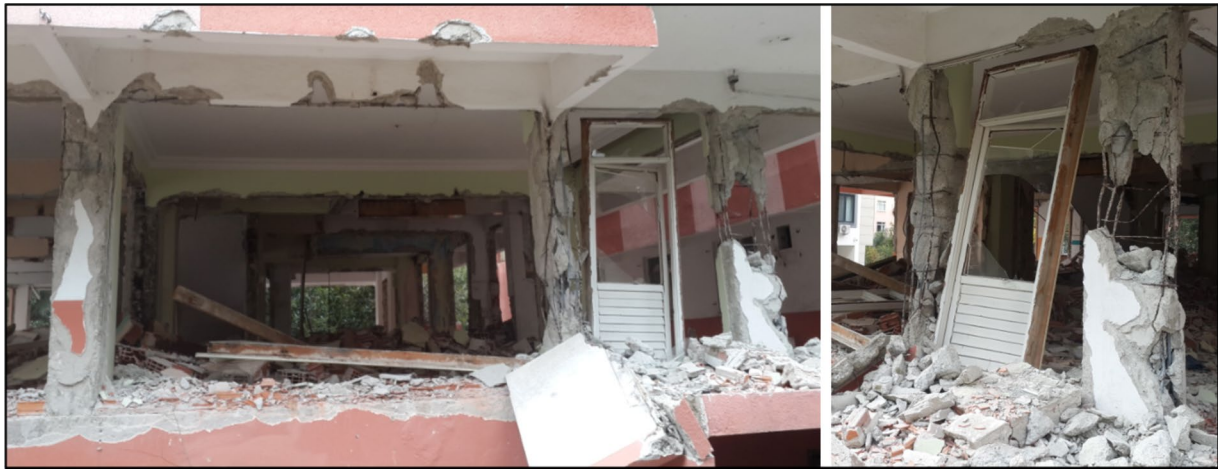
In this phase, two corner columns were heavily damaged. They were razed, and Fig. 9 shows the damaged elements in this phase. Figure 10 shows the singular values of spectral density illustration. The first three dominant frequencies of the building were determined as 2.578, 2.793, and 3.164 Hz, proving that the second mode frequency did not change, but the frequencies of other modes decreased slightly. Mode shapes visually remained the same as those for the undamaged building. One distinct difference concerning the previous case was the dominant frequency seen at 12.168 Hz. The mode shape evaluation pointed out that this mode did not

Fig. 9 Two heavily damaged corner columns for HD-I

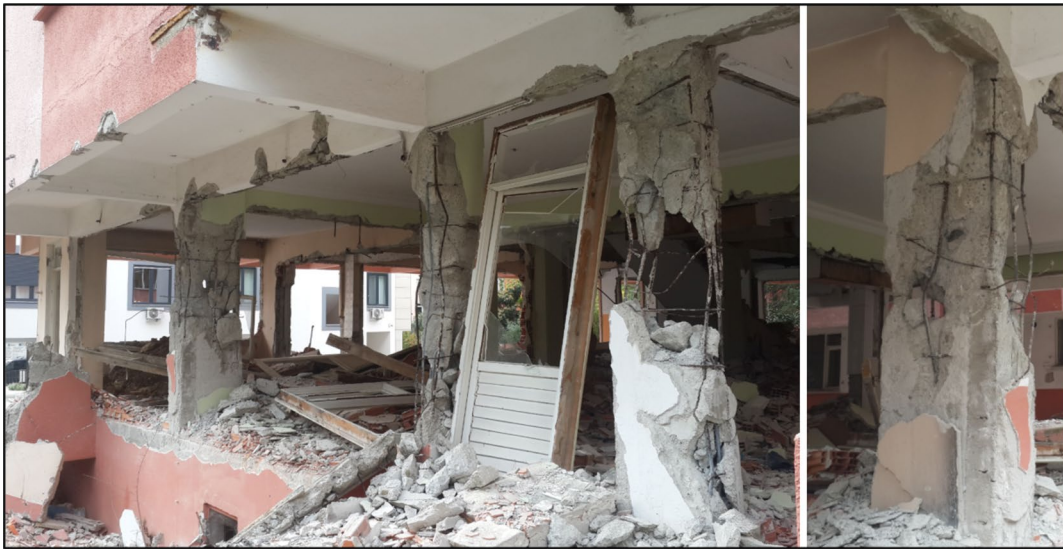
The moderately damaged column was heavily damaged in this phase. Figure 11 shows the damaged elements and Fig. 12 shows the singular values of spectral density illustration for the HD-II phase of the building. The dominant frequency of the second mode did not change again, but those

**Fig. 11** Heavily damaged three columns for HD-II
