# Monitoring the dynamic properties of a nine-story reinforced concrete building during its demolition

**Summary**

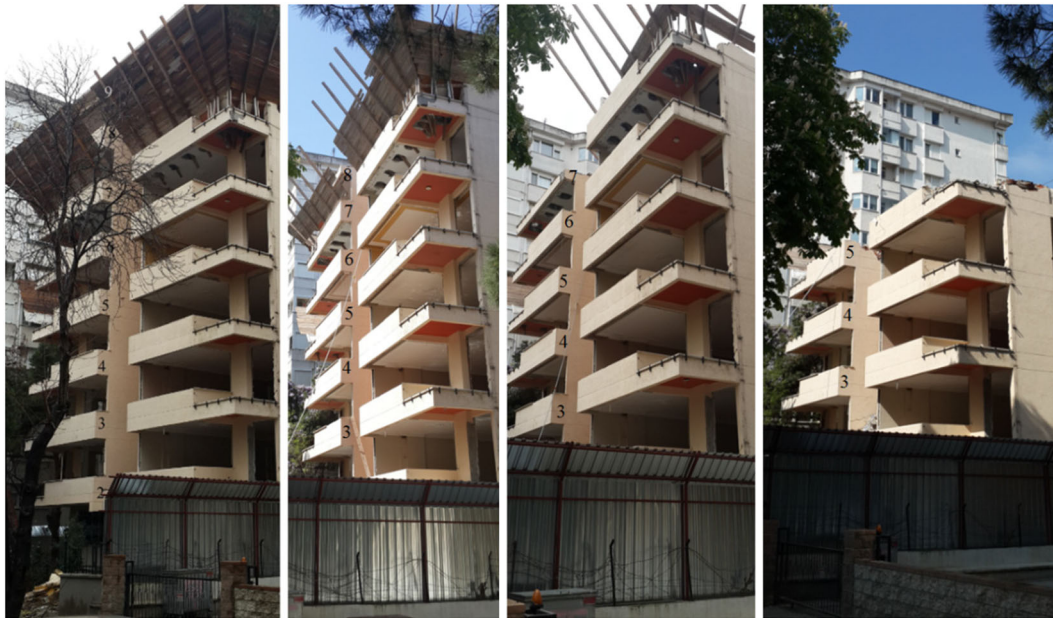
**FIGURE 5** Floor removal in the studied building

The demolition of the studied building was performed first by the removal of the top stories. For this aim, a building demolishing machine was located on the roof level of the building, and it demolished its surroundings to reach to the story below. The wrecks were thrown down. Figure 5 shows the nine-, eight-, seven-, and five-story phases of the studied building.

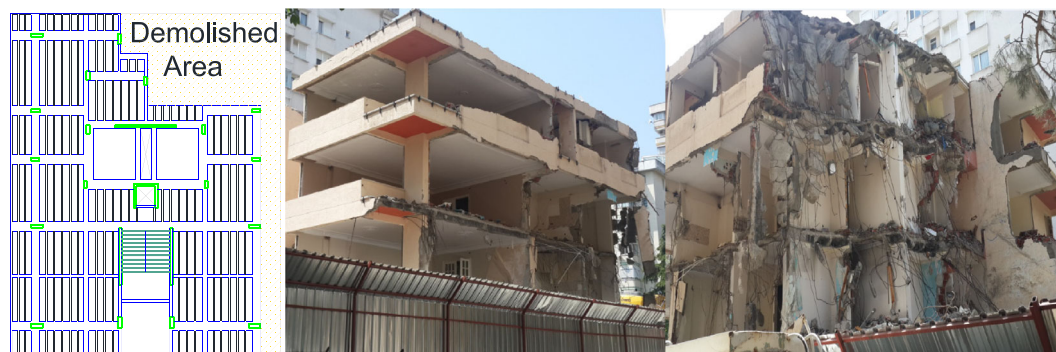
**FIGURE 9** The studied building after the first ground demolishing

After a working day, approximately 20% of the plan area, taking the third floor as the reference, was demolished as seen in Figure 9. The modal analysis was performed in that stage with the measurements gathered from the second and fourth stories of the building. The dominant frequencies were obtained as 3.51, 5.20, and 9.05 Hz as shown in Figure 10. All the dominant frequencies correspond to torsion mode. Therefore, the structural behavior of the building is governed by three torsional modes.

Demolition of the five-story building with an excavator is pursued with vertical slices. Here, impacts are applied, and structural members were broken down. In these stages, the geometry of the building is changed as seen through Figures 9, 11, 13, and 15.

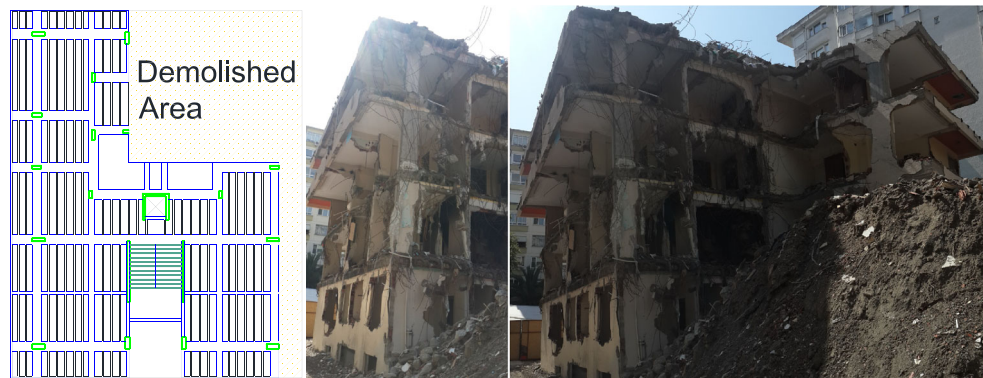
**FIGURE 11** The studied building after the second ground demolishing

After an additional day, 30% of the plan area of the building was demolished. The present phase of the studied building is shown in Figure 11 with its plan layout on its third floor. The analysis of the measurements, gathered from the second and fourth stories of the building, gave the dominant frequencies as 3.41, 4.77, and 8.74 Hz as seen in Figure 12. Like in the previous form of the building, the dynamic modes were governed by torsional behavior.

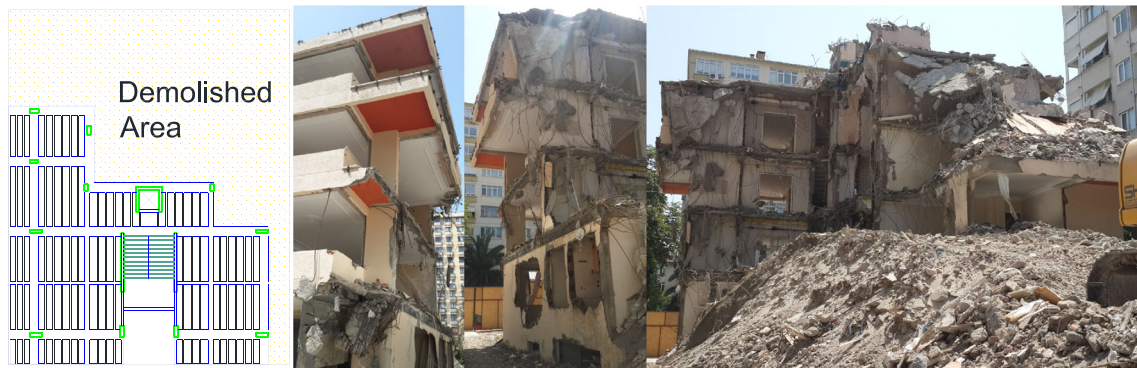
**FIGURE 13** The studied building after the third ground demolishing

Almost 50% of the plan area of the building was demolished in the next day. Figure 13 shows the building with its remaining portion. The analysis of the measurements, gathered from the second and fourth stories of the building showed that the number of peaks is increased for the accounted frequency range. In that respect, a furcation phenomenon took place. As seen in Figure 14, 3.15, 4.41, 5.01, 6.86, 7.83, and 9.82 Hz are the dominant frequencies referring to the torsional modes.

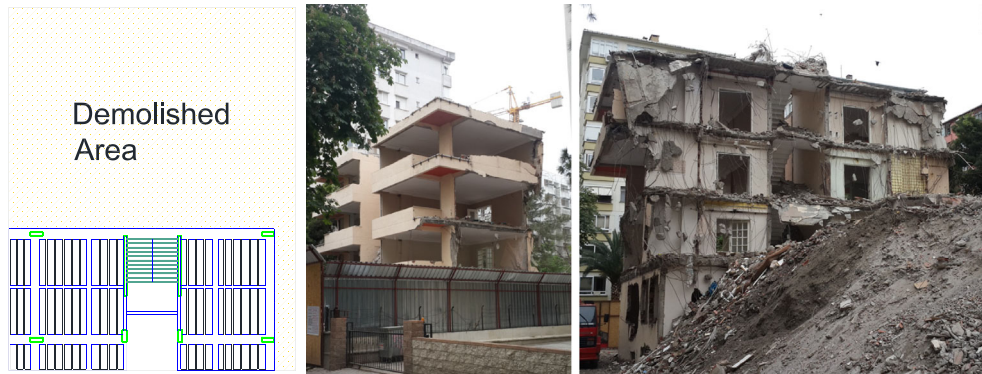
**FIGURE 15** The studied building after the fourth ground demolishing

The last vibration recording is performed when 65% of the plan area of the building was demolished. The building with its plan layout is shown in Figure 15. Because of the broken stairs of the building, the fourth floor could not be reached; thereby, the vibration measurement is performed on the second floor of the building. As seen in Figure 16, the analysis of the measurements revealed the increased number of dominant frequencies as in the previous case. In this stage, singular values of spectral densities are represented for each direction separately in Figure 17 by analyzing the data in Matlab.<sup>37</sup> As it is seen, the dominant frequencies can be detected in both directions separately, referring to a modal displacement also proving the torsional behavior.
