# Monitoring the changes in the dynamic properties of an RC building experiencing column loss

Fuat Aras<sup>1</sup> · F. Necati Çatbaş<sup>2</sup>

Received: 3 April 2023 / Accepted: 20 February 2024 / Published online: 26 March 2024  
© The Author(s) 2024

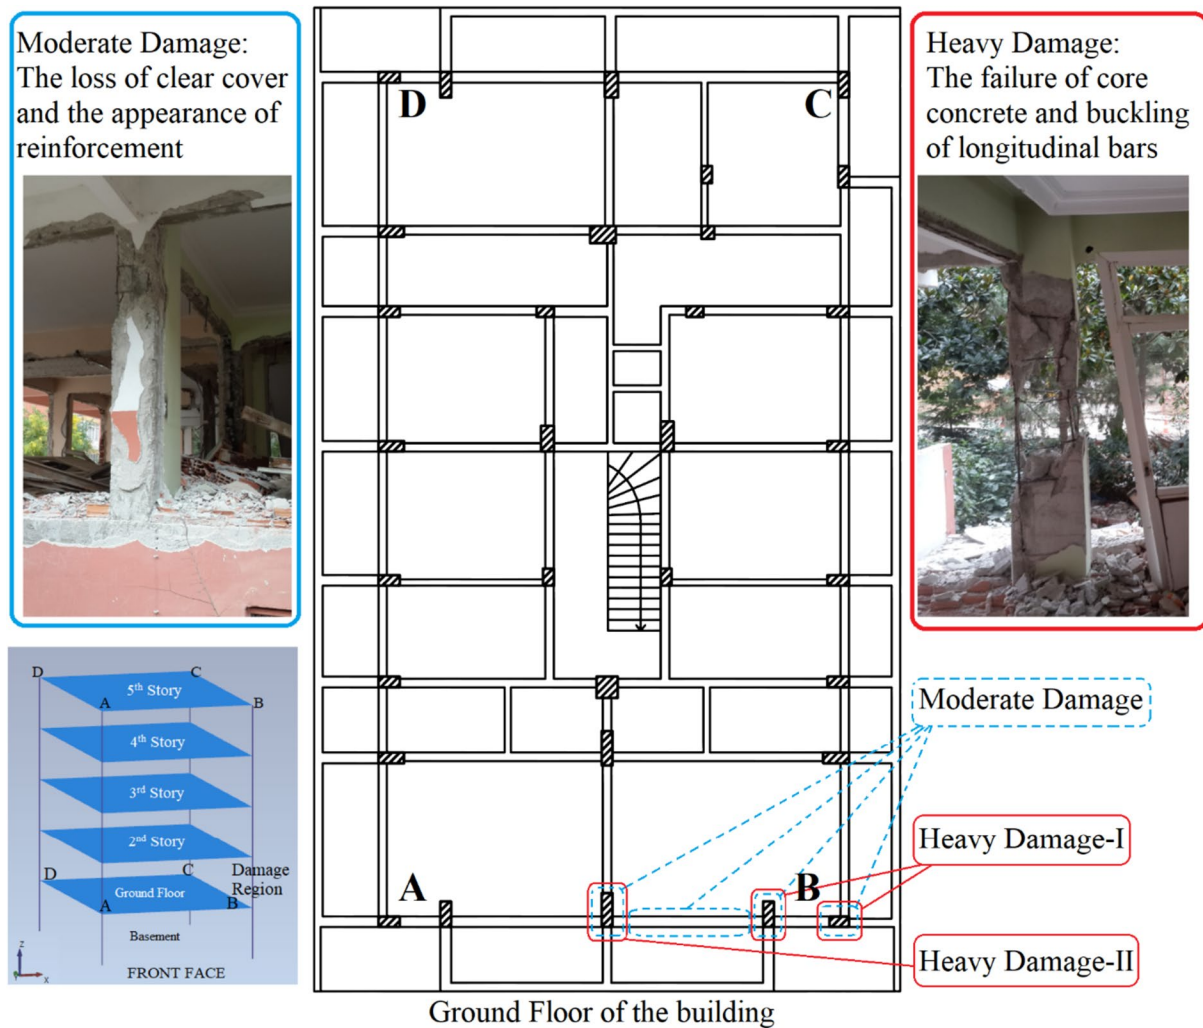
**Fig. 3** Defined damage levels and their locations on the ground floor of the building and AVS model

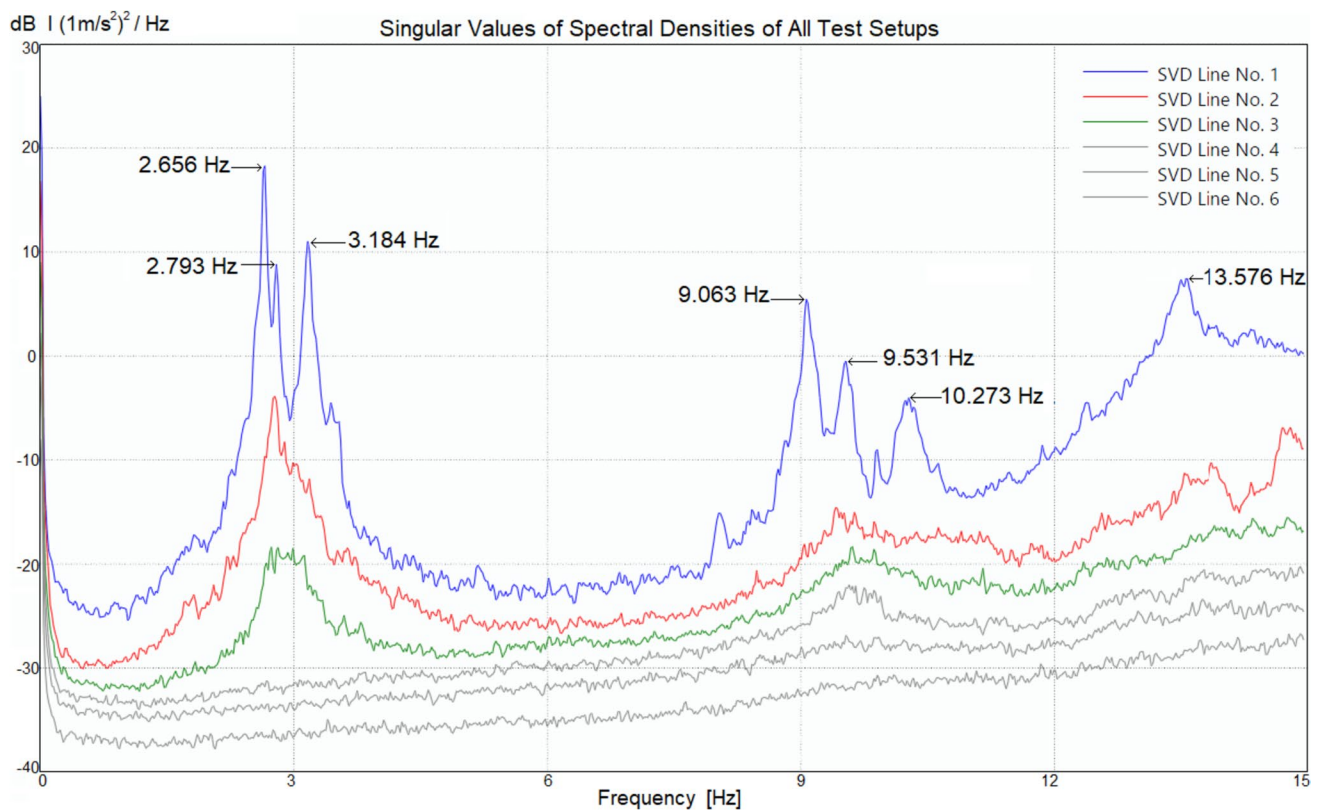
AVS was applied to the building with the same principles explained before. The first three dominant frequencies of the building were determined as 2.656, 2.793, and 3.184 Hz (Fig. 8). The general mode shape definitions of the building remained the same as those determined for the undamaged building. Concerning the previous phase, a slight decrease in the dominant frequencies was noted. The same conclusion is valid for the higher modes except for the fifth mode.

**Fig. 8** Singular values of spectral density for the MD phase of the building

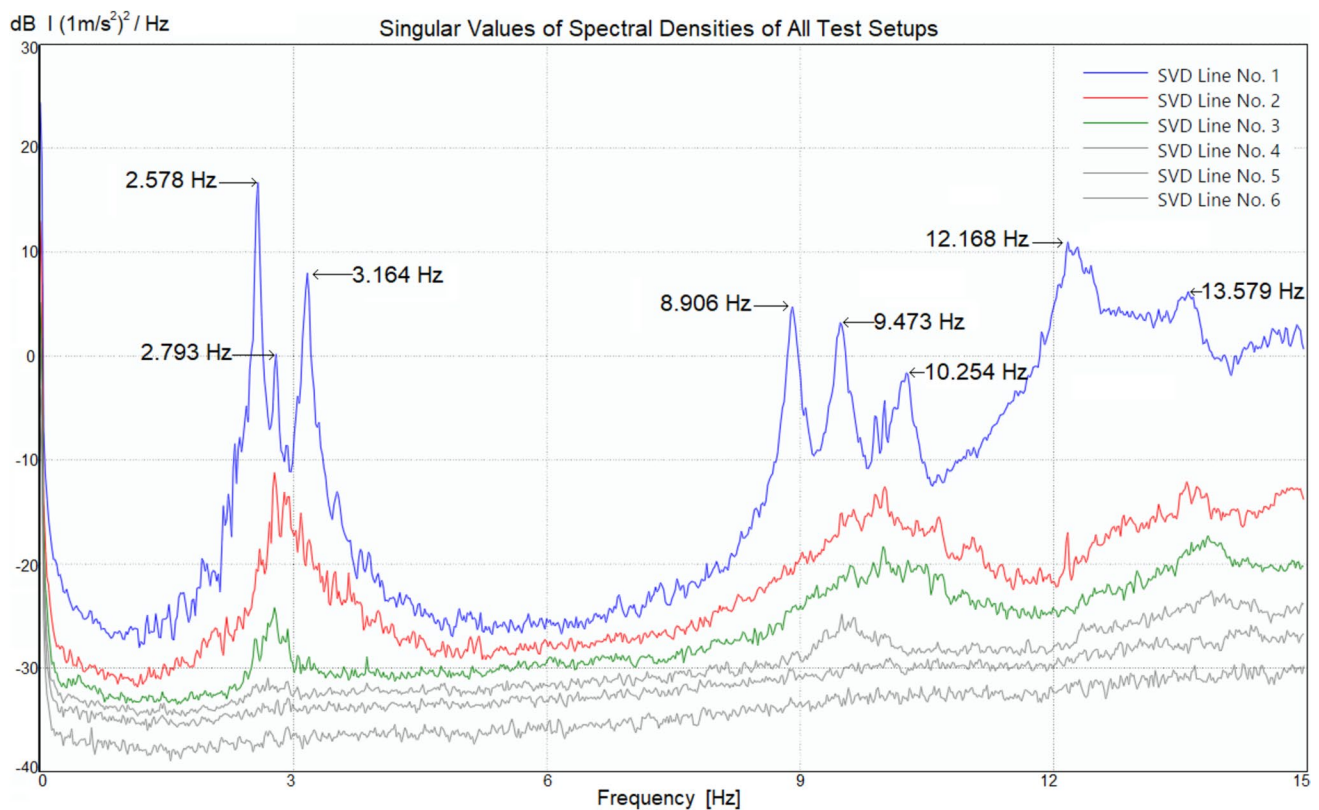
In this phase, two corner columns were heavily damaged. They were razed, and Fig. 9 shows the damaged elements in this phase. Figure 10 shows the singular values of spectral density illustration. The first three dominant frequencies of the building were determined as 2.578, 2.793, and 3.164 Hz, proving that the second mode frequency did not change, but the frequencies of other modes decreased slightly. Mode shapes visually remained the same as those for the undamaged building. One distinct difference concerning the previous case was the dominant frequency seen at 12.168 Hz. The mode shape evaluation pointed out that this mode did not

Fig. 10 Singular values of spectral density for HD-I

exist for the previous cases and it was formed by the vertical movement of corner *B*, where column damages existed on the ground floor. In other words, the given damage created a vertical mode.

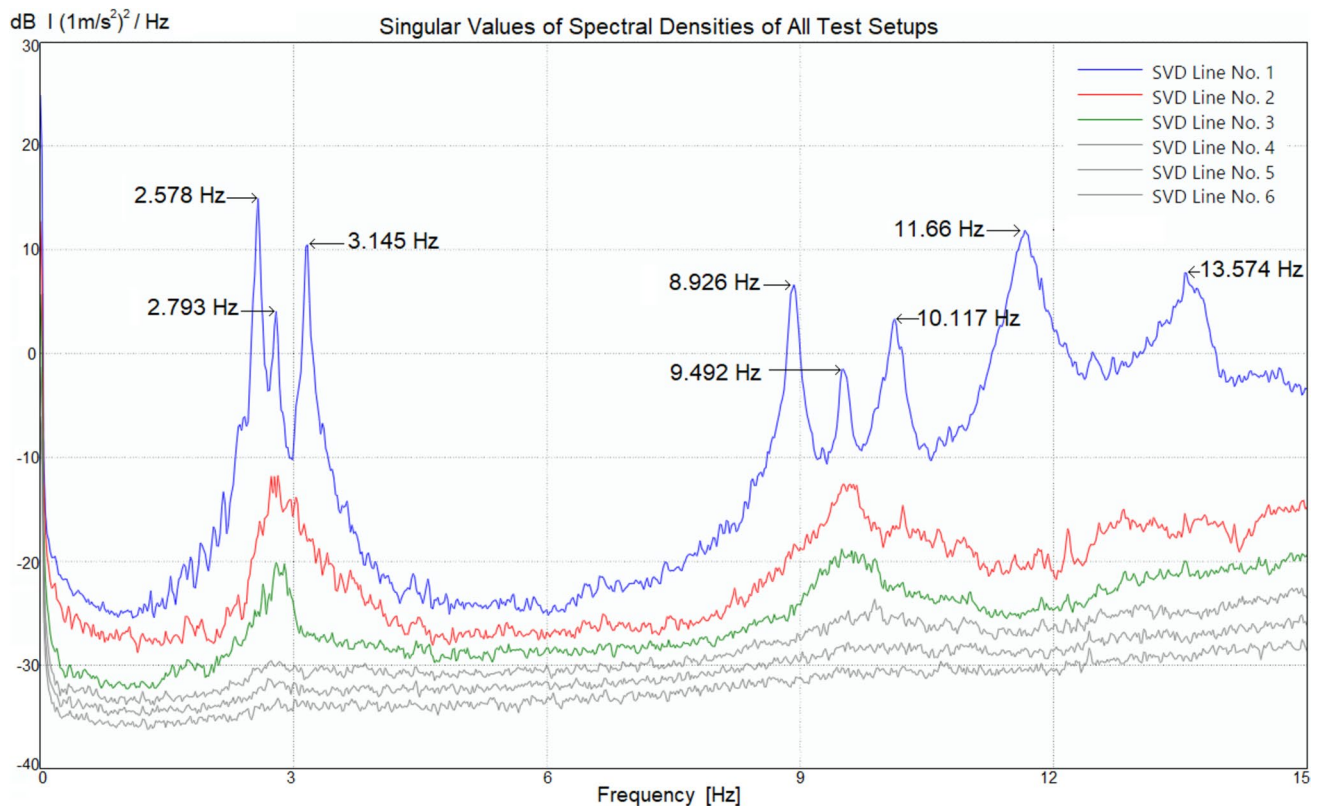
The moderately damaged column was heavily damaged in this phase. Figure 11 shows the damaged elements and Fig. 12 shows the singular values of spectral density illustration for the HD-II phase of the building. The dominant frequency of the second mode did not change again, but those

**Fig. 12** Singular values of spectral density for HD-II

of other modes decreased slightly. Mode shapes remained the same as those for the original building. The vertical mode induced by the heavy damages had a dominant frequency of 11.66 Hz.

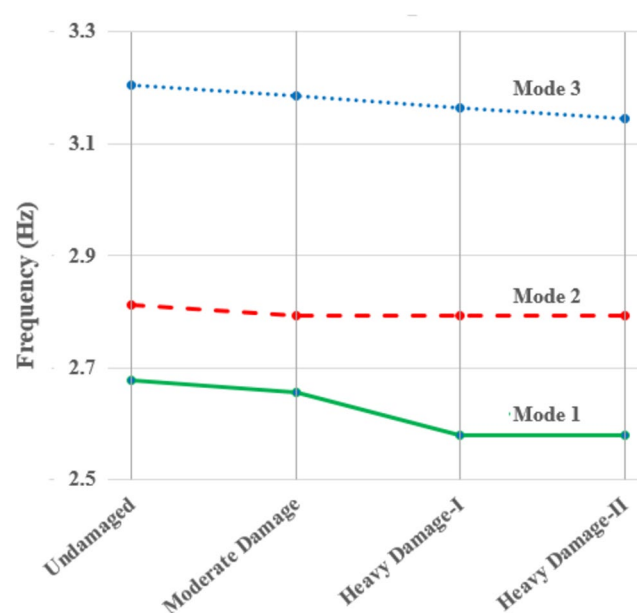
**Fig. 14** The first three modal frequencies of the building through the sustained damage levels

The first mode frequency of the building decreased with the experienced damage. Unexpectedly, the decreases for the HD-I and HD-II phases are the same. The obtained second mode frequencies of the building are the same for all damage stages and it is 0.71% less than that of the undamaged building. The third mode frequency decreases with the increase in the severity of the damage. The complete loss of three columns (out of 32) on the ground floor caused a decrease of less than 4% in the dominant frequency of the first mode. Such a small amount of decrease can be regarded as an insignificant change to worsen the dynamic behaviour of the building. For the decision-makers working on the assessment of partially damaged buildings, the result can favour the repair or retrofit of them.

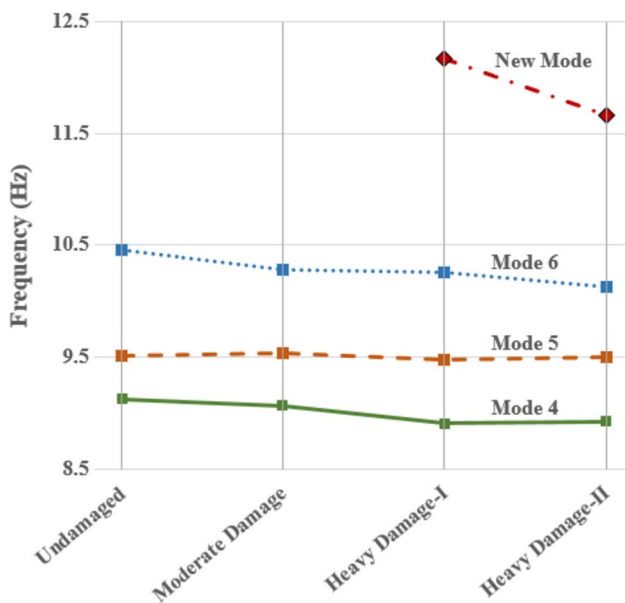
**Fig. 15** The variation of the modal frequencies of higher modes through the sustained damage levels

The loss of two corner columns in the HD-I phase makes the corner  $B$  unsupported in the vertical direction. For this reason, a new mode, which did not exist for the undamaged and moderately damaged building, was created with a dominant frequency of 12.168 Hz. When the building lost one more column, the dominant frequency of the new mode decreased to 11.66 Hz. In this study, numerical analyses were also employed for the validation of the experimental results.
